## Tihange 2 RPV Material Integrity : *New Inspections & “New” Cracks ?*

- **Mechanisms for Instability and Potential Growth of ‘Hydrogen Flakes’ during reactor operation**

**Walter F. BOGAERTS**

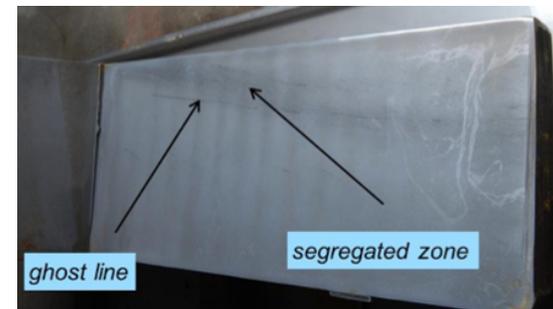
VB 395  
component

- Unexpected atypical “indications”
- Various measuring methods
- Up to 40 per dm<sup>3</sup> (!); total **7776** (& much more, according to new measurements (2014) : total: **13,047** !?)
- Down to a depth of (30) to 120 mm (measured from primary water side)
- Concentration in bottommost and upper core shell
- Located in base metal, outside of weld regions
- Can be correlated to steel microstructure & thermo-mechanical history (theoretical modeling SCK-CEN)
- ...

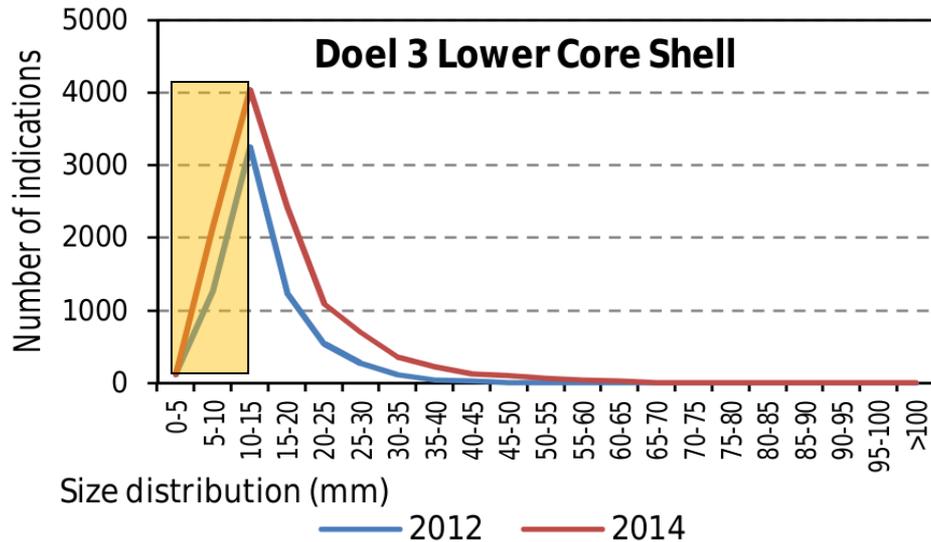
Statistical Distribution of Crack Sizes in 2012 compared to 2014  
(Source: Fanc/Electrabel)

Yellow border shows typical range of real Hydrogen Flakes

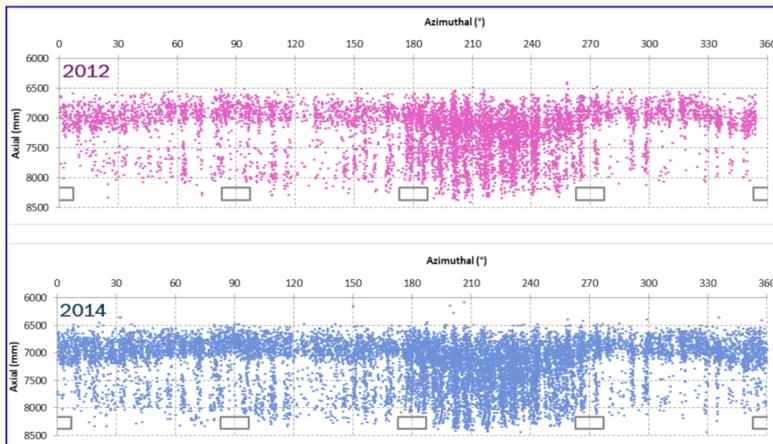
***Distribution of the flaws over the Doel 3 lower shell circumference, measured in 2012 (upper part) and in 2014 (lower part).***

**13.047 "indications" in Doel 3.149 (?) in Tihange**

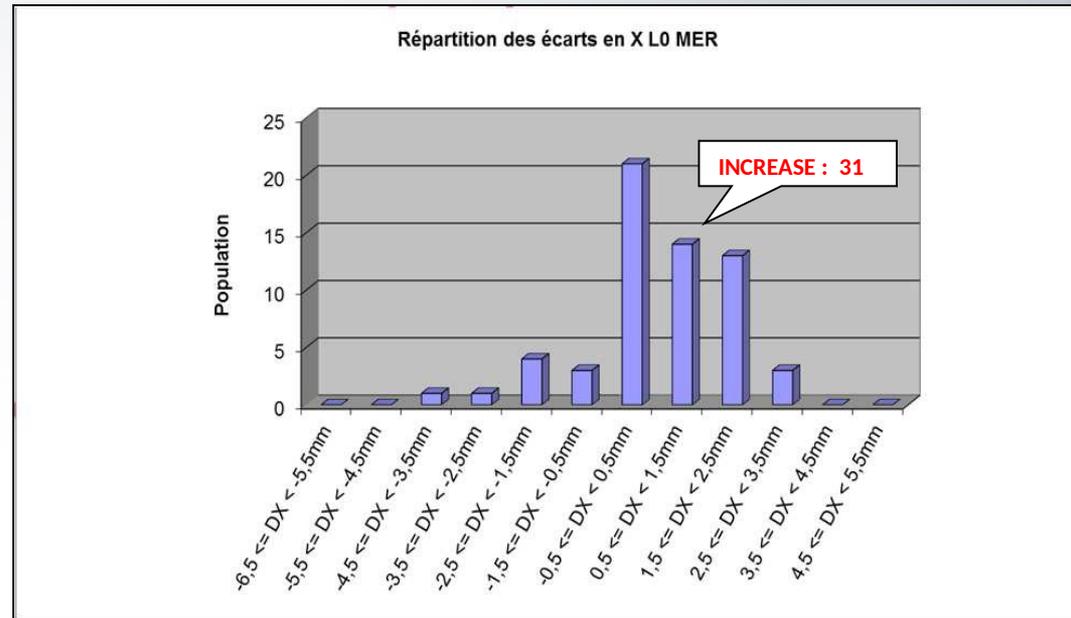
*after operation:*  
**Tihange 2**

- 60 “new” cracks discovered in 2017
- But: also present in 2014  
*(new data analysis)*
- Some sizes 5...15...  
25% larger

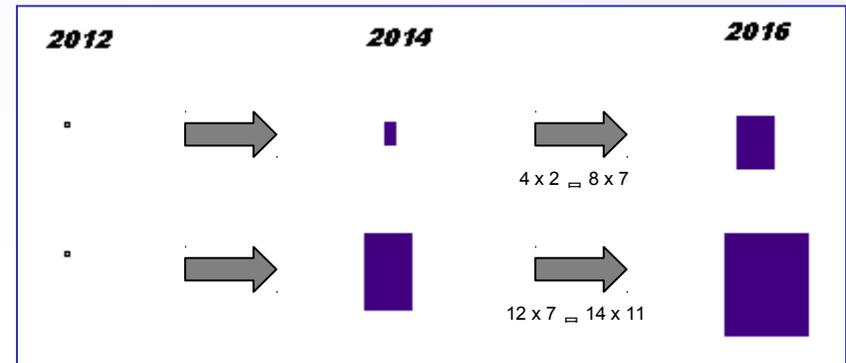
### Doel 3

- 300 “new” crack discoveries in 2016
- 8 difficult to explain “outliers”
- Example:  
“Indication nr. 30060” ...
