Fweer / W. Renneberg: rial Problems in Reactor Pressure Vessels: Doel 3/Tihange 2

Material Problems in Reactor Pressure Vessels: Doel 3/Tihange 2

Ilse Tweer / W. Renneberg

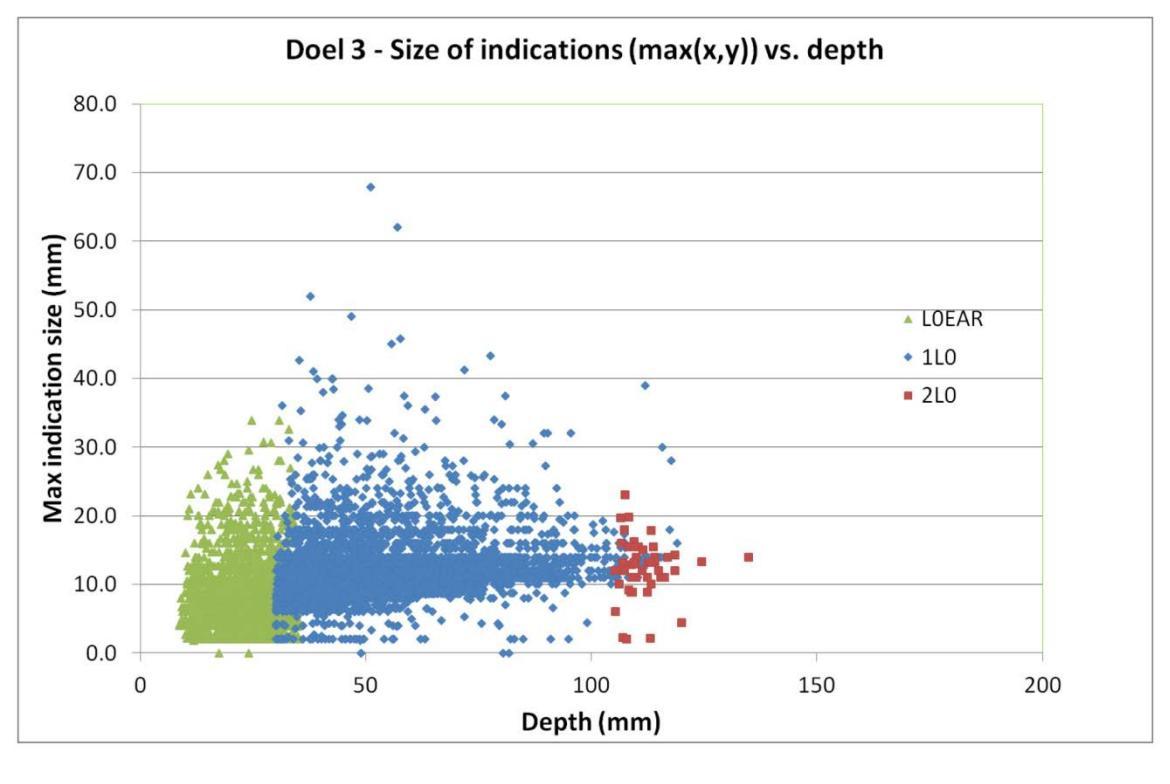
Figure 1: Indication sizes at Doel 3

The Belgian nuclear authority FANC informed the public in the Provisional Evaluation Report⁷ (page 23/24) that the flaws in the depth ranges up to 120 mm from the inner clad surface have mean sizes of 10-14 mm, "some exceeding 20-25 mm" in the case of Doel 3, and "maximum size 24 mm" 2 in the case of Tihange. This statement is a clear contradiction to the figure published by Electrabel⁸ (fig. 1): the number of flaws with sizes above 25 mm is significantly more than "some". The observed flaws were describes as quasi-laminar, i.e. parallel to the inner surface in about 100 mm depth.

In February 2015 FANC published revised data of the number of flaws and their sizes⁹: According to FANC the operator of the two power plants found during the required qualification of the inspection method that this method did "*not allow to detect all flaw indications, and that the method used for the interpretation of the signals tended to underestimate the dimensions of a small part of the detected flaw indications. In May and June 2014 the operator conducted new ultrasonic inspections in Doel 3 and Tihange 2 with the result of even higher flaw indication sizes.*"

The hardly understandable fact that indications with sizes up to 179 mm have not been detected during acceptance testing after manufacture has not be explained by the Electrabel and FANC. In spite of this fact Electrabel claims that no growth of the flaws has occurred during operation. There is also no unquestionable explanation for the increase of number and sizes of flaws between 2012 and 2014. "Bel V concludes that the updated condition of the Doel 3 and Tihange 2 RPV core shells as revealed by the examination performed in 2014 using the qualified UT inspection procedure is to be considered as having a substantially increased structural significance when compared to the condition determined in 2012."¹⁰

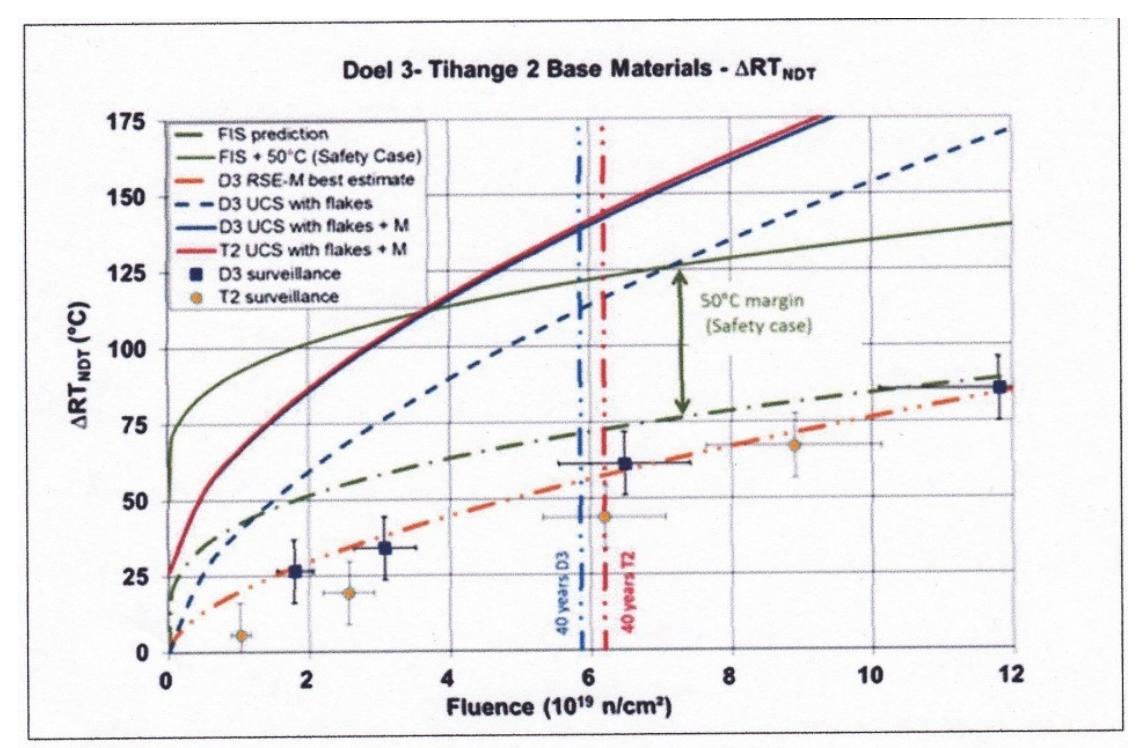
Figure 3: Trend curves for shift of reference temperature RT_{NDT}

In the Safety Case 2015 Electrabel replaced the enveloping FIS curves as applied until 2012 by these trend curves that include the composition dependent term from the French standards³¹ and a fluence dependent term that is supposed to reflect the radiation effects observed using the VB395 samples³². Figure 3 shows the old and new trend curves (shift of the reference temperature RT_{NDT}). The new trend curves are no more enveloping curves but average value curves with standard deviation margins (M): $RT_{NDT SIA} = RT_{NDT,init} + \Delta RT_{NDT,RSE-M} + \Delta RT_{NDT,VB395} + M$

At first sight the new trend curves seem to be more conservative than the former FIS curves in the end-of-life fluence range. But since the fluence at the position of the flaws within the RPV wall is lower than at the inner surface of the wall the lower frequency range ($3-4 \ge 10^{19} \text{ n/cm}^2$) is relevant³³.

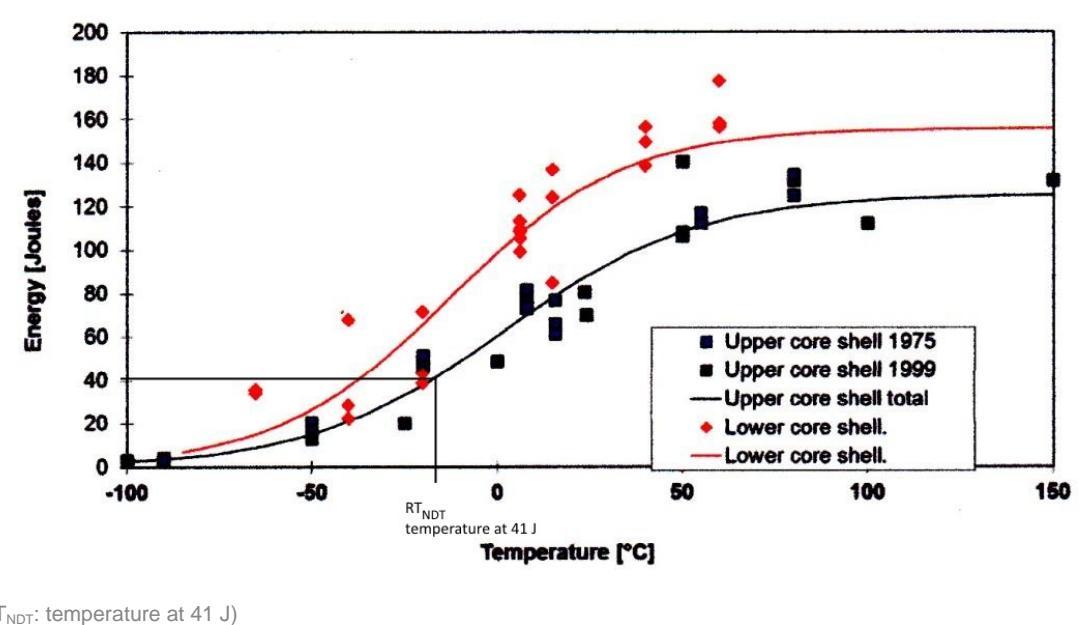
Comparing the RT_{NDT} values for the initial (unirradiated) state of the base metal as used by Oak Ridge National Laboratory - ORNL (table 3) with experimental data sheets³⁸ for Ti-hange 2 upper core shell (black curve in figure 4) the following can be observed:

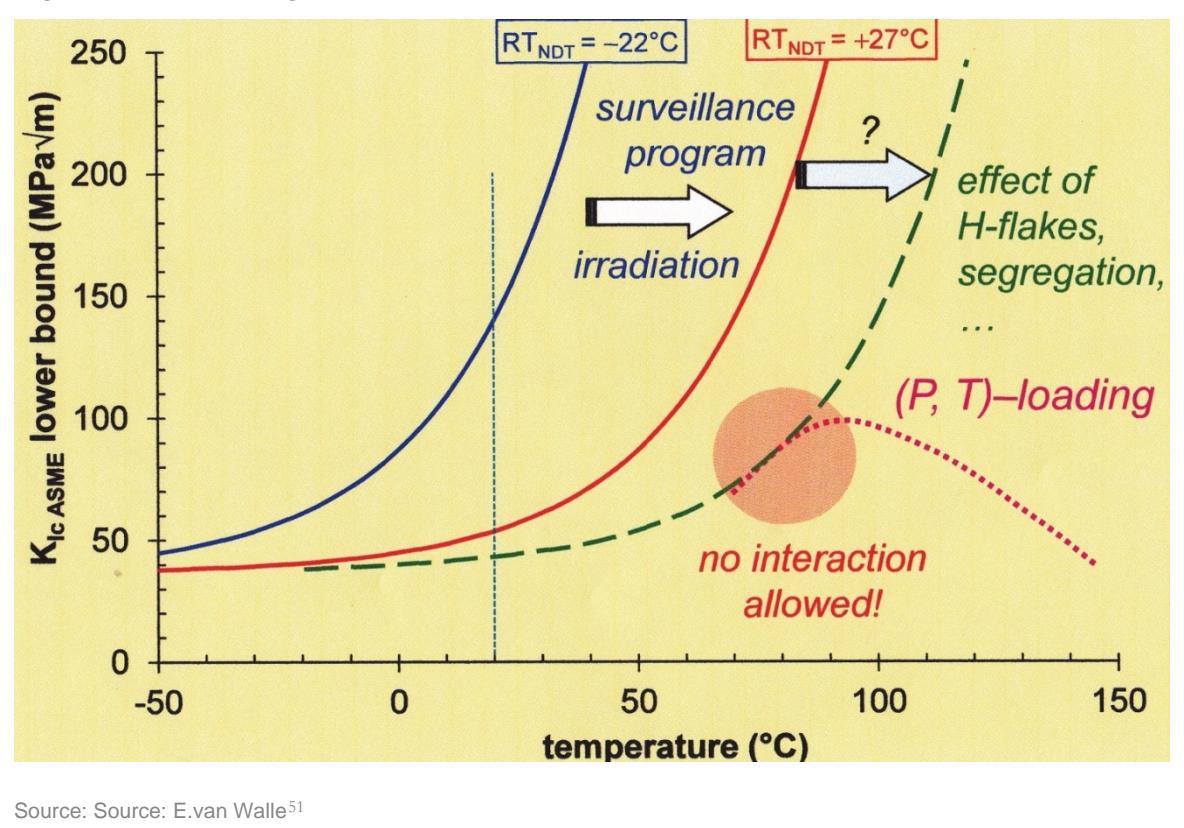
Figure 5: Fracture toughness curve

The calculated load path for each assumed crack is than compared with the fracture toughness curve based on embrittlement assumption by predictive trend curves and the respective fluence at the crack position (see the preceding sections) as shown in figure 5. The load path may not intersect the fracture toughness curve (the diagram is equivalent to the ASME acceptance criterion describes below).

Comparing the calculated load path (stress intensity versus temperature during the accidental transient) with the lower bound fracture toughness curve the tangency of the two curves gives the critical RT_{NDT} . This critical value may not be reached until end of life. This is the so called ASME acceptance criterion:

- $RT_{NDT(crit)} RT_{NDT(final)} > 0$: acceptance criterion is satisfied
- $RT_{NDT(crit)} RT_{NDT(final)} < 0$: acceptance criterion is not satisfied

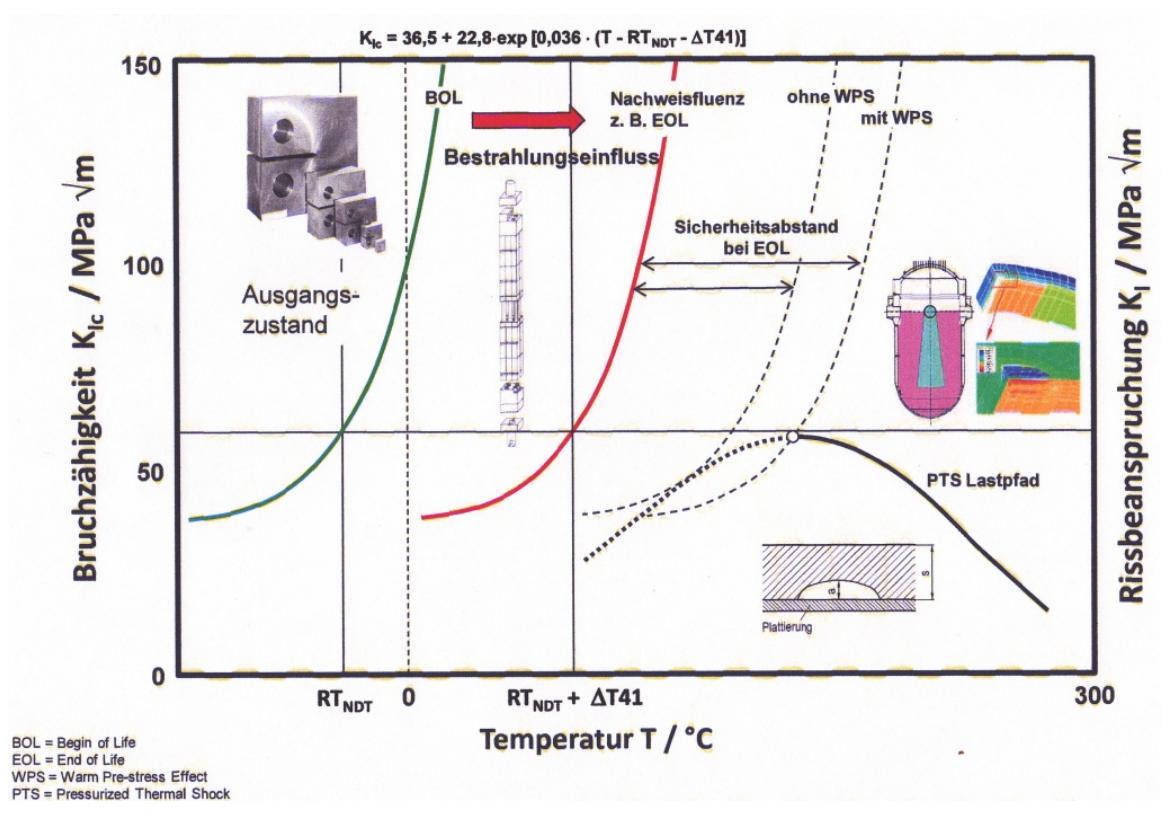
Warm prestress is a phenomenon that the fracture toughness of steels in the lower shelf region is enhanced by preloading at high temperatures. The effect was observed at notched samples and has been studied with a variety of experimental conditions. The effect seems to be dependent on these conditions.⁵⁶ The experiments were performed with small and component-like samples but not with complete pressure vessels.

The application of the WPS effect means that the tangency of the load path with the fracture toughness curve occurs after the reaching the maximum of the load path as can be seen in the figure 6.
