## Tihange 2 RPV Material Integrity : *New Inspections & “New” Cracks ?*

- **Mechanisms for Instability and Potential Growth of ‘Hydrogen Flakes’ during reactor operation**

**Walter F. BOGAERTS**

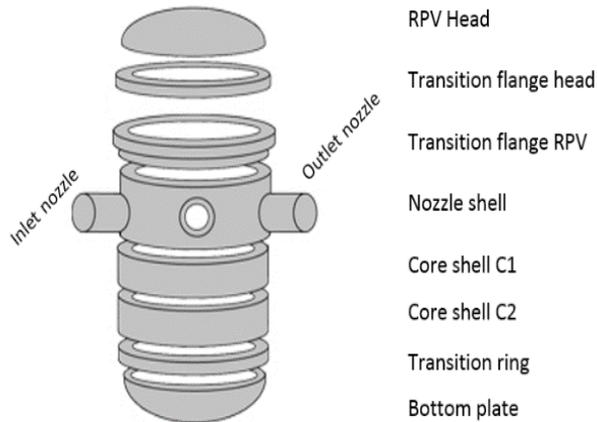
*Illustration translated from FANC, showing the original forged steel ring sections of the RPV separated for clarity. These rings are welded together and clad internally with a stainless steel lining to form the reactor pressure vessel.*

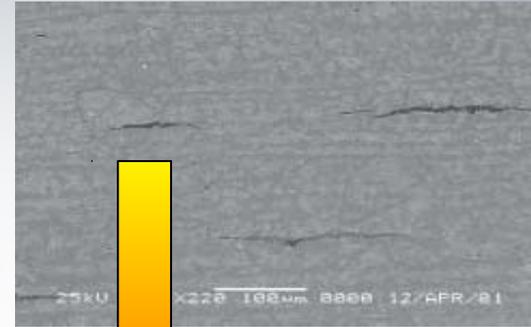
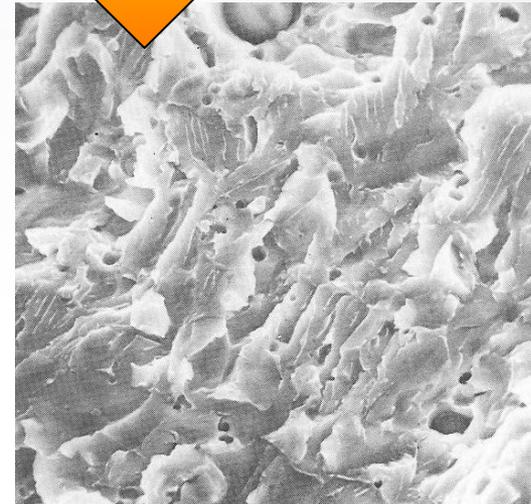
*Typical flake cracking in carbon or low-alloy steel. Typical features of hydrogen-induced brittle fracture are: micro-quasi-cleavage fracture, pores and fine hair-lines (indicating ductile fracture on a micro-scale)*

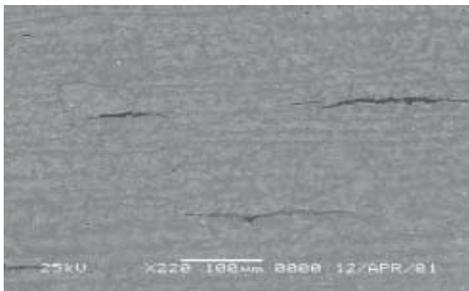
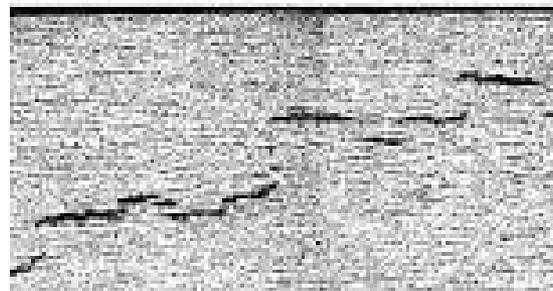
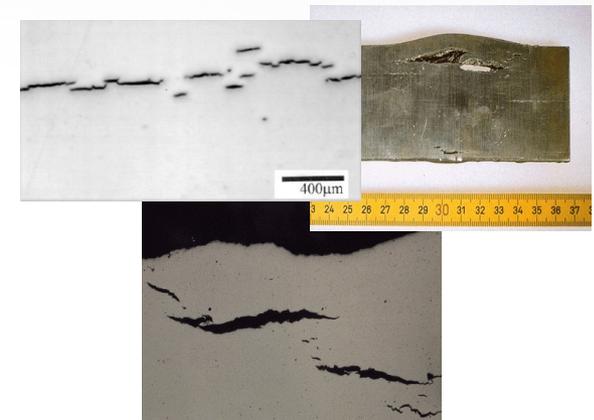
- A most significant concern is the possibility of having **through-thickness flaw linkage**, due to the high density of flaws in some zones
- Such types of morphology appear to occur in pressure equipment where the hydrogen damage is associated with hydrogen charging from the process environment (see [API 579-1/ASME FFS-1 2007 Fitness-For-Service](#)).

*Typical hydrogen induced cracks*

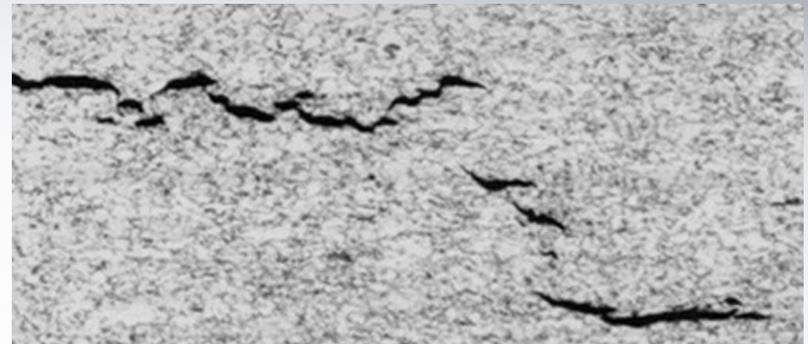
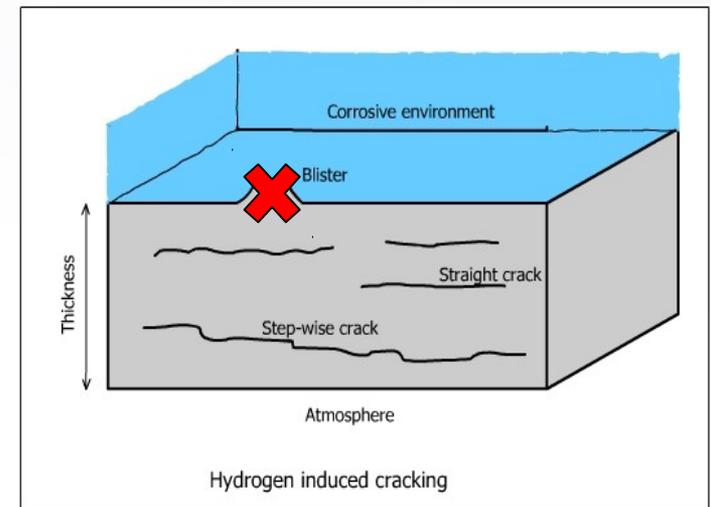
- Typical sizes: 4 to 15 mm
  - “Current findings”: up to ~~20, 25 or 30 mm~~ (!?)
    - Doel (13.047) : **68** [179\*] mm (vertical)  
x **38** [72] mm (horizontal)
    - Tihange (3.149) : **38** [155] mm (vertical)  
x **25** [71] mm (horizontal)

\* Figures released – February 2015 (data dd. May-June 2014 & adapted detection parameters)

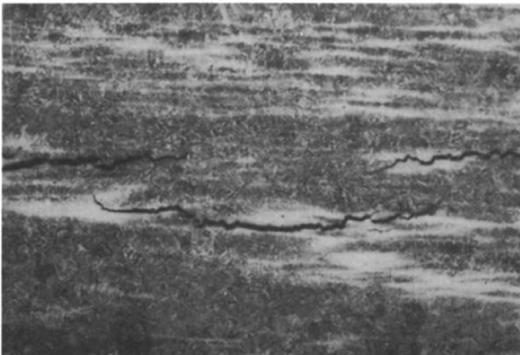
Fig. 3. Flakes in a hot-rolled 25 mm plate.

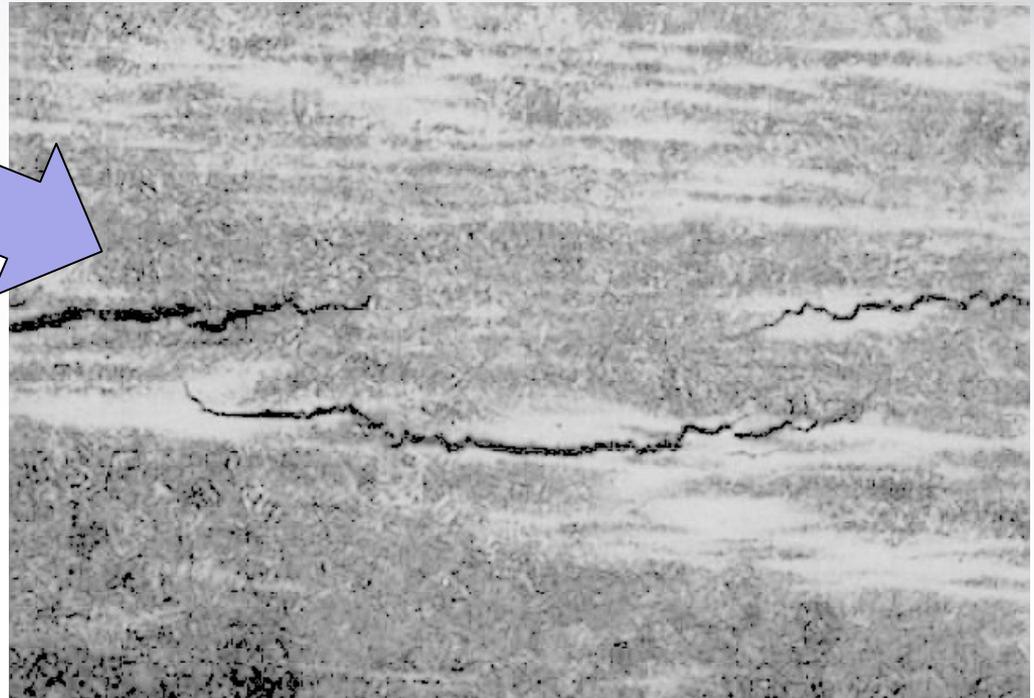
FANC: Het zijn géén  
scheurtjes, het zijn ...

Fig. 3. Flakes in a hot-rolled 25 mm plate.

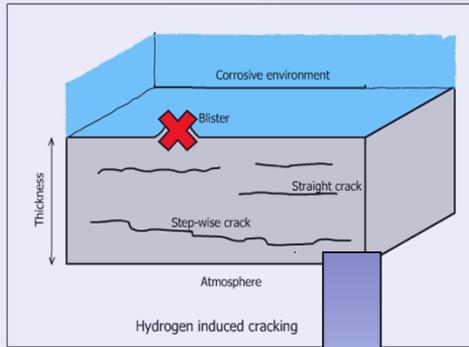
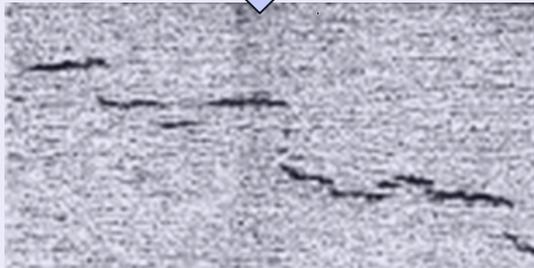
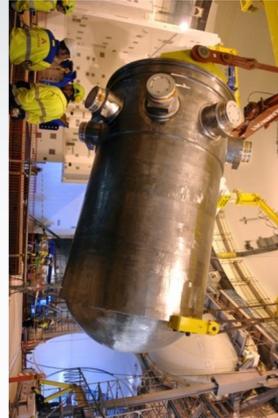
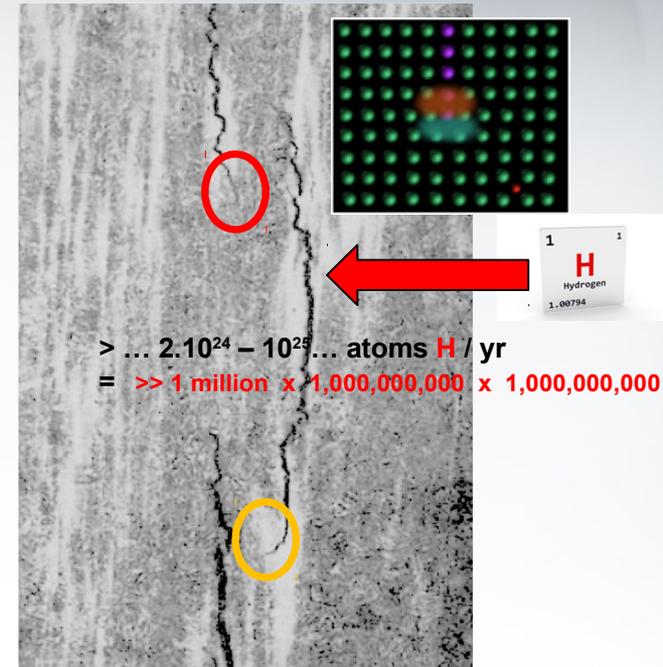
e.g.: *“hydrogen-induced stepwise cracking”*

Flakes in a hot-rolled 25 mm plate.

**Total: 13.047 (!)...**

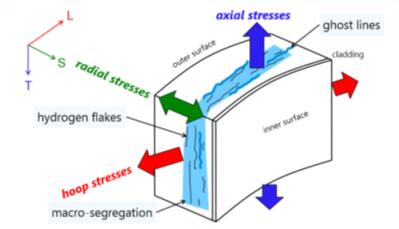
***Distribution of the flaws over the Doel 3 lower shell circumference, measured in 2012 (upper part) and in 2014 (lower part).***

**13.047 "indications" in Doel 3.149 (?) in Tihange**

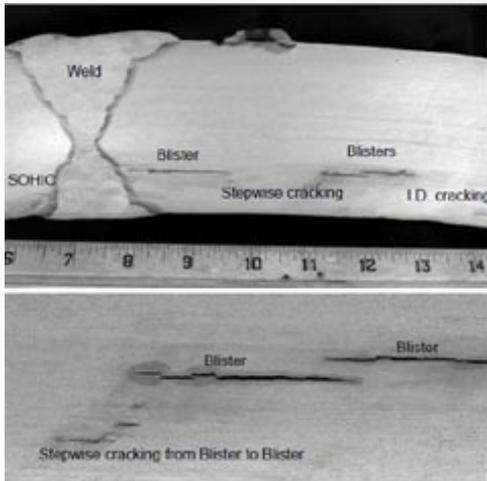
**Blisters:** A planar cavity formed as a result of hydrogen charging. Typically the indication will show some variation in through-wall depth and does not display a smooth profile. There is normally a noticeable through-thickness extent- which may be confirmed by Time of Flight Diffraction (TOFD). Loss of back-wall signal is greater than that found with laminations. Length and/or breadth would typically exceed 25mm. Blisters are normally discovered near to process or outer surface of the plate and under some circumstances may be seen visually as a bulging of the plate surface.

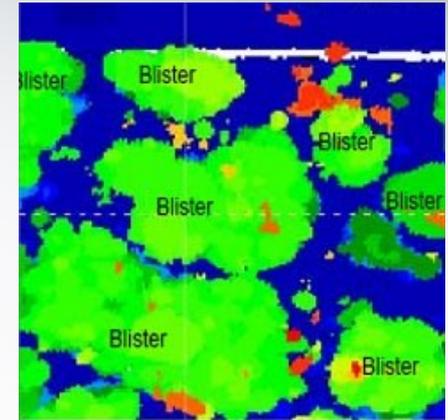
**HIC:** Planar cavity formed as a result of hydrogen charging. Individual cracks are generally quite small in area (length and/or breadth less than 25mm) and have no measurable through-thickness extent. HIC may be isolated (i.e. one by itself) or form clusters of cracks. Clustered HIC involves areas of individual HIC in close proximity to one another, both in terms of area and through-thickness extent, normally within 1 to 3mm. Note, although the cluster might show some through-thickness extent, the individual cracks in the cluster do not.

**SWC:** The CGI image of SWC is similar to that obtained for Clustered HIC (above), however SWC also exhibits through-thickness cracking, resulting in the linking of individual HIC cracks on multiple planes. These features are normally detected by the use of Time of Flight Diffraction (TOFD) and 45° shear wave ultrasonic. The extent of the through-thickness cracking is normally established by TOFD

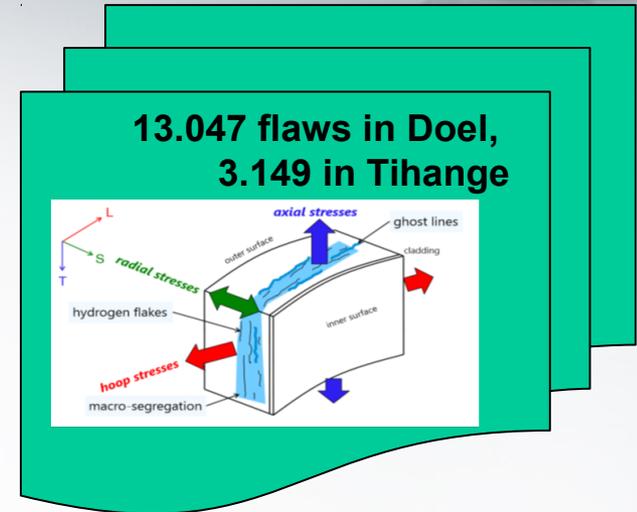
- 60 “new” defects in Tihange 2
- Growth in size (?!)

In general : “aging of process equipment” & safety !?
